# Analysis of Road Damage Using the PCI Method (Case Study on Tambak Osowilangon Road)

**Arell Adritama and Diah Ayu Restuti**

Narotama University

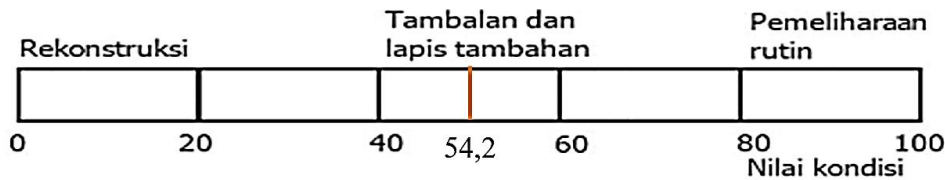
Figure 2. Asphalt Institute Method

From the results of the PCI calculation, a value of 54.2 is obtained which means it is sufficient, so for recommendations for improvement using the method Asphalt Institute is like the picture below

Which shows the road is in sufficient condition, then the road which is damaged with potholes needs to be patched and overlaid so that the former patch and cracks and other damages that occur along the road are covered. by hotmix asphalt so that water does not quickly seep into the road layer which causes the damage to be getting worse.
